COMPREHENSIVE REPORT
INVESTIGATION OF MILITARY CONSTRUCTION
IN ARCTIC AND SUBARCTIC REGIONS
1945-1948

APPENDIX I
AIRFIELD SITE STUDIES
AT NORTHWAY AIRFIELD, ALASKA

OFFICE OF THE CHIEF OF ENGINEERS
AIRFIELDS BRANCH
ENGINEERING DIVISION
MILITARY CONSTRUCTION

JUNE 1950

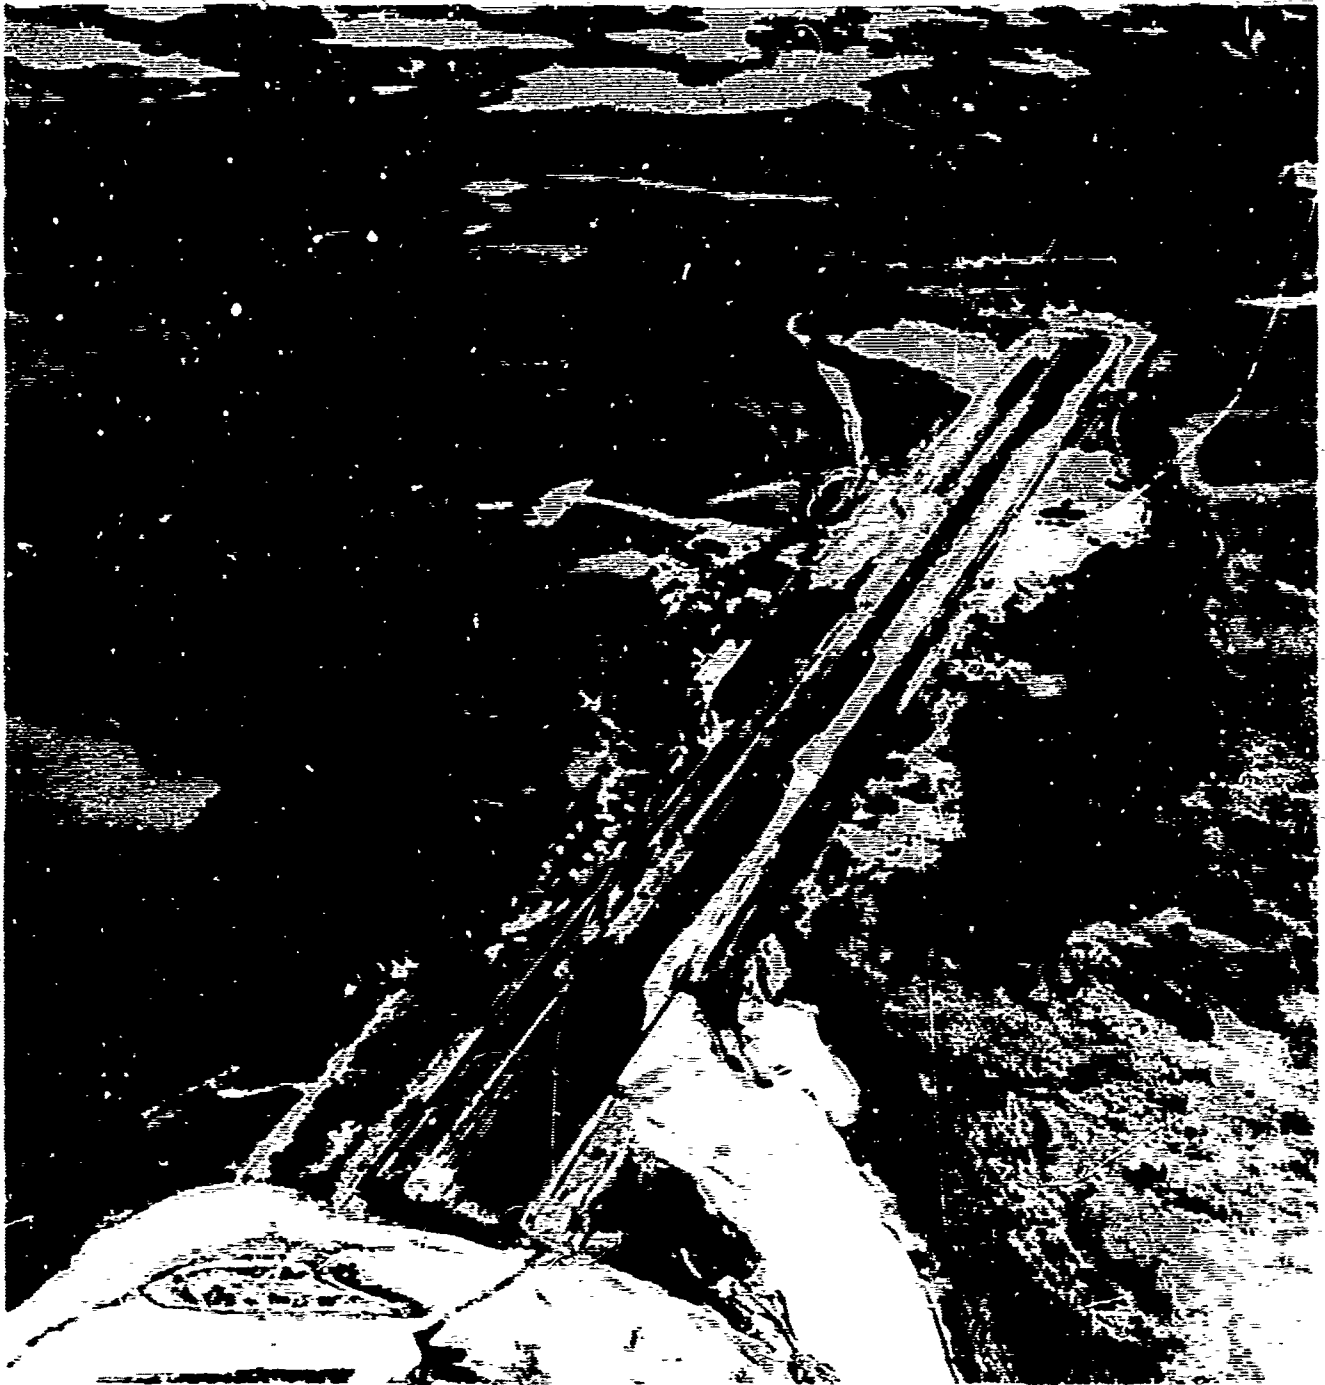
Figure I-1. Northway Airfield, Alaska, June 1946

3. **LOCATION, TERRAIN AND DRAINAGE.** Northway Airfield is located at $62^{\circ} 58'$ north latitude, $141^{\circ} 58'$ west longitude in the flood plain of the Nabesna River and its tributary, Moose Creek. It is about 230 air miles southeast of Fairbanks, Alaska and 30 air miles west of the Canada-Alaska boundary. For a topographic map of the area see Plate I-1. The airfield was constructed on a relatively flat flood plain of the Nabesna River and its tributary, Moose Creek. A sand dune underlies the northeastern end, and the

southwestern end rests on an abandoned drainage channel once occupied by the Nabesna River. The balance of the field is located on an interchannel area of a flood plain which includes portions of several cave-in lakes. The vegetation consists of scattered groves of spruce, birch and aspen with numerous willow thickets. The ground is covered with a thick carpet of moss and peat. Below a 3- to 6-ft surface layer subject to seasonal thawing and freezing, the permafrost layer exists in varying thicknesses of from 90 to 150 ft. Figure I-1 shows in excellent detail the airfield and the surrounding terrain. Except for a few minor sections and for a short period of time during the summer months, no normal groundwater table exists at this site due to the proximity of the upper surface of the permafrost to the normal ground surface. Deep groundwater determined by well drilling operations was encountered below the permafrost layer at a depth of approximately 240 ft+ below the surface, and is used for a potable water supply. The general trend of surface drainage is to the south toward Moose Creek. Runway drainage was provided by construction of parallel side ditches permitting surface and storm waters to drain into the Nabesna River and Moose Creek.

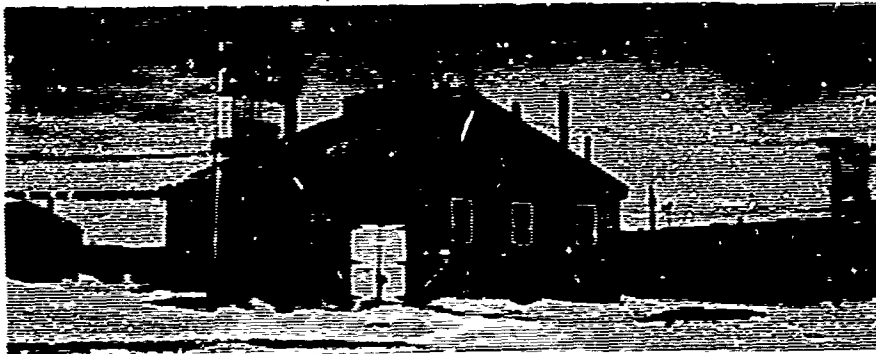
Figure I-4. Northway Airfield powerhouse, looking northwest (previous to fire on 25 December 1946). May 1946

11. POWERHOUSE. The powerhouse was a rigid frame structure placed on a reinforced concrete slab of over-all dimensions of 55.7 ft by 65.3 ft. See Plate I-21 and

Figure I-4. At the start of construction operations late in the fall of 1943, it was considered advisable to take special precautions to insure a stable foundation for the two large 350 kva d. c. generators. To accomplish this, the area selected for the powerhouse was temporarily inclosed in a framed canvas structure and the ground steamed and excavated to a variable depth from 5 ft to 7 ft below the

- (3) Vertical movement. For the period of observation from 3 April 1945 to 15 November 1946, the 9 observation points on pier footings showed an average maximum settlement of 0.082 ft, with a minimum settlement of 0.033 ft at point 15 and a maximum settlement of 0.190 ft at point 12. For the same period of observation, the 4 observation points on the north generator base showed that the average maximum settlement was 0.11 ft with a minimum of 0.053 ft at the SW corner, and a maximum of 0.134 ft at the NE corner; whereas, the average maximum settlement of the 4 observation points on the south generator base was 0.078 ft, with a minimum of 0.056 ft at the SW corner, and a maximum of 0.104 ft at the SE corner. Up to the time of its destruction by fire, the powerhouse required no unusual maintenance for either the structure or generators, and could be considered stable.

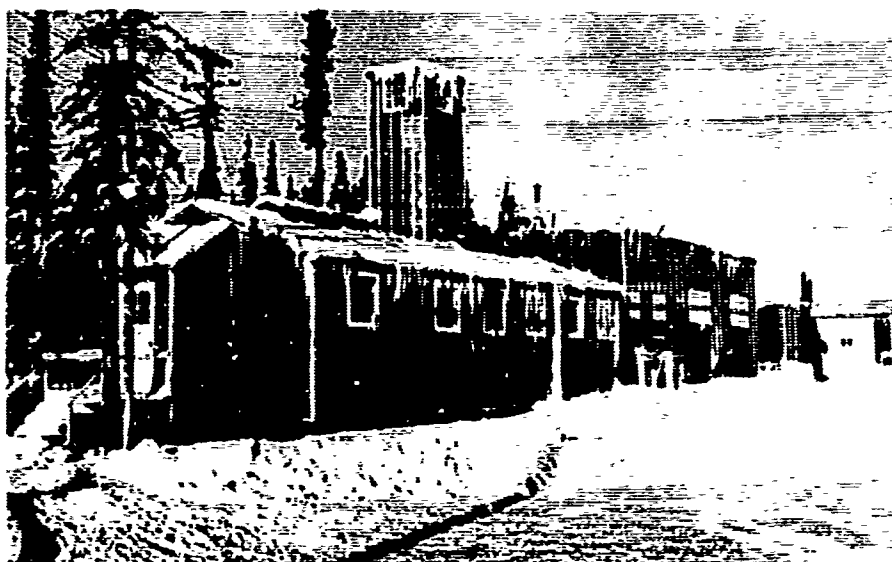
Figure I-6. Northway Airfield fire station, looking northwest. Crews' quarters in foreground, hose tower in center, fire station proper in right background. February 1947

13. FIRE STATION. The fire station is an L-shaped, standard, theater-of-operations type structure. Its foundation is supported on timber piling placed butt down well into the permafrost in such a manner as to provide approximately a 2-1/2-ft air space between the bottom of both the wood and concrete floors and the normal ground surface. No skirting of the air space beneath the building was made except along the north wall where a fill was placed to serve as an approach ramp. Construction operations commenced in the summer and were completed in the late fall of 1944. The operational section of the structure is constructed on a reinforced concrete floor slab, while the crew quarters section is on an insulated wooden floor. See Plate I-23 and Figure I-6.

- a. Subsurface explorations. Plate I-8 shows boring hole 41, located 6 ft outside and east of the northerly section of the east wall of the fire station, which was subsequently used for the installation of a mercury thermometer ground temperature reading assembly. A review of the boring log will show that the fire station was constructed on materials of the following classifications to a depth of 25 ft below surface: 0 to 5 ft, poorly graded sand and silt; 5 to 15 ft, poorly graded sands and gravels; 15 to 25 ft, fine gray sands, silty sands, and some ice lenses. This material is suitable for timber piling foundation construction if an air space is used.

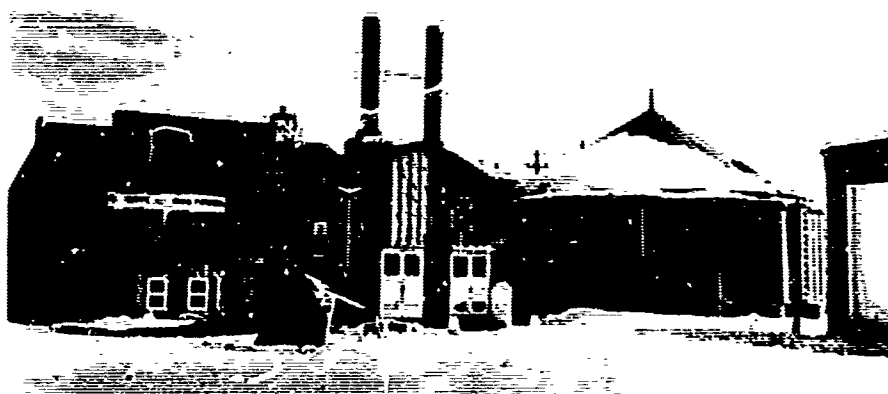
Figure I-7. Northway Airfield boiler house, looking southeast. Boiler house in center foreground. 100,000-gal. water storage tank right rear, powerhouse left rear. May 1946

frame structure constructed on a reinforced concrete floor slab, which in turn is supported on timber piling placed well into the permafrost in such a manner as to provide approximately a 2-1/2-ft air space between the bottom of the floor slab and the normal ground surface. Construction was accomplished in the spring of 1944. See Plate I-24 and Figure I-7.

- a. Subsurface explorations. No specific observation boring was made in the immediate vicinity of this structure. However, hole 22 (see Plate I-8) located at the north side of the powerhouse and near the boiler house, shows a classification of base and subbase materials to a depth of 25 ft below surface as follows: 0 to 1.0 ft, moss and peat; 1 to 5 ft, poorly graded sands with little or no fines; 5 to 15 ft, poorly graded gravels and sand with traces of silt; 15 to 25 ft, poorly graded sand, fine sands, sandy silt, and peat with ice lenses. Under natural conditions, permafrost is normally encountered in varying depths from 3 to 5 ft below surface.

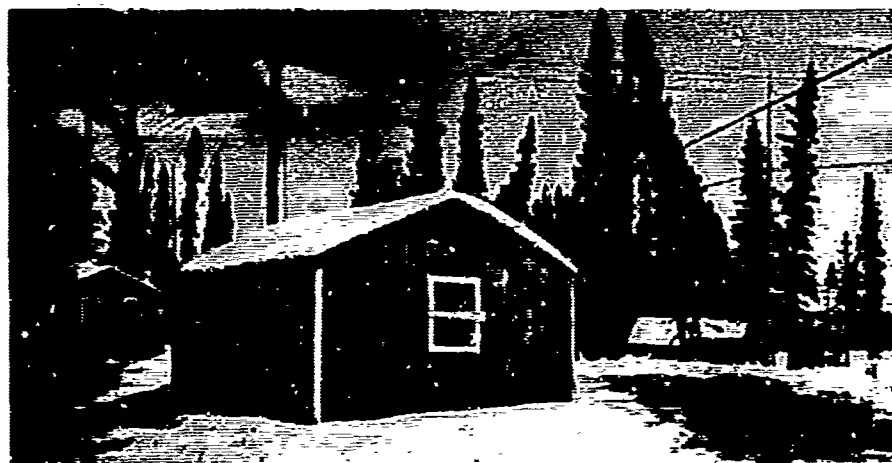
Figure I-8. Northway Airfield pump house no. 2, looking northwest -- Liver Lake in background. May 1946

15. **PUMP HOUSE NO. 2.** Pump house no. 2, which was constructed primarily to supply water to the dispensary and the adjacent troop barracks, is a 16-ft-4-in. by 18-ft-4-in. rectangular frame

structure supported approximately one foot above normal ground surface on 8-in. reinforced concrete walls which extend through the active zone into the permafrost. Subsequent to the well drilling operations, and prior to foundation construction, the surface materials in the area, consisting of moss, peat and fine-grained soils, were excavated to an approximate depth of 2-1/2 ft and replaced with granular materials

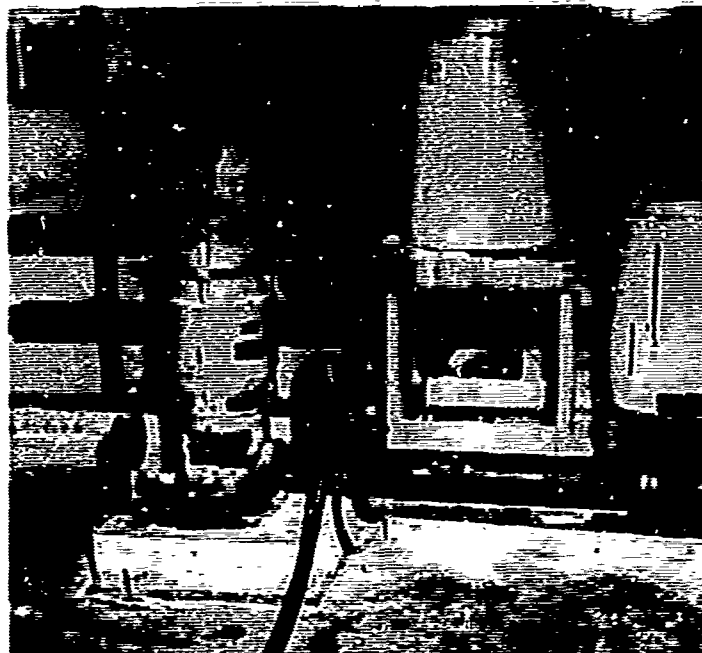
Figure I-11. Northway Airfield pump house no. 1, interior view showing stability of pump foundation. December 1947

a depth of approximately 150 ft below the surface. A suitable water-bearing gravel stratum was obtained at a depth of 242 ft. Upon completion of drilling operations the pump house was constructed. As a result of the continuous heating operations in the temporary structure enclosing the drill rig, the underlying surface and subsurface materials were thawed to a depth in excess of 6.0 ft. These thawed fine-grained materials were removed and replaced with granular materials, which were compacted to serve as a base for the pump house structure, the pressure water tank and the pump foundation proper. The structure is of the same type as pump house no. 2, see Plate I-24. As this structure is stable and in good condition, no observations were taken in or around it. A combination of the effect of the steam drilling and the temporary structure heat had undoubtedly compacted the underlying subsoils sufficiently to provide suitable bearing capacity, and subsequent frost action was prevented by the thawing action of continuous pumping operations. See Figure I-11 for an inside view of the pump house.
